**Subject: Slauson Tanker Response  
Emergency Response Report  
Los Angeles, Los Angeles County, California  
TDD No.: 0002/1302-T2-R9-17-04-0002  
Document Control No.: 0149-08-ACDX**

This letter report presents a summary of the ER site activities. Attachment A provides figures for the ER and Attachment B provides a photographic log of Site conditions during the ER.

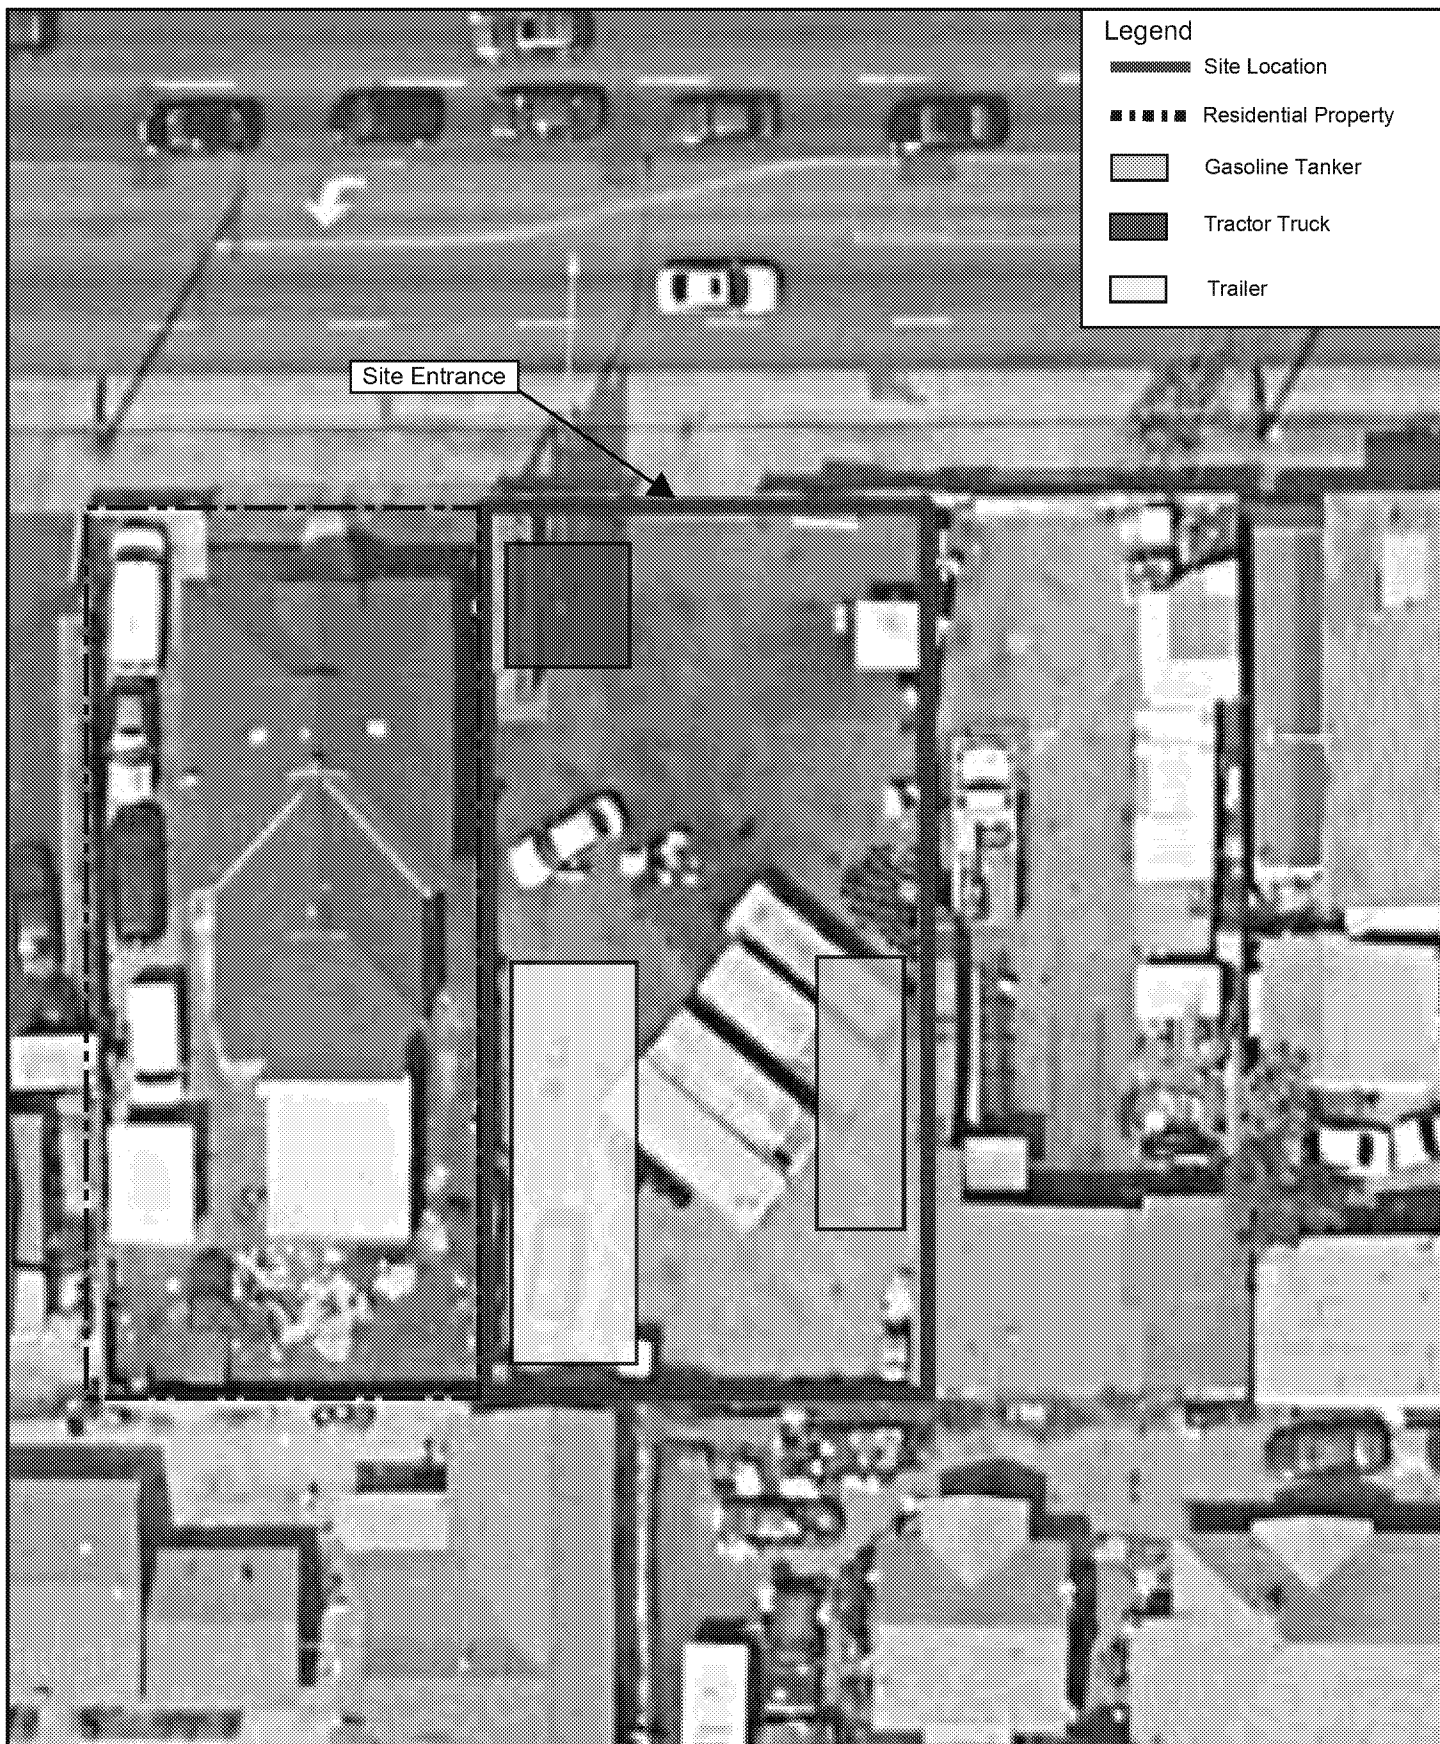
**FIGURE 2**  
**SITE LAYOUT**  
 Slauson Tanker Response  
 210 West Slauson Avenue,  
 Los Angeles, Los Angeles County, California

remnants of the fuel tanker were located on the southeast portion of the Site. The Site is an almost uniformly asphalted surface. A Site Layout is presented in Figure 2.

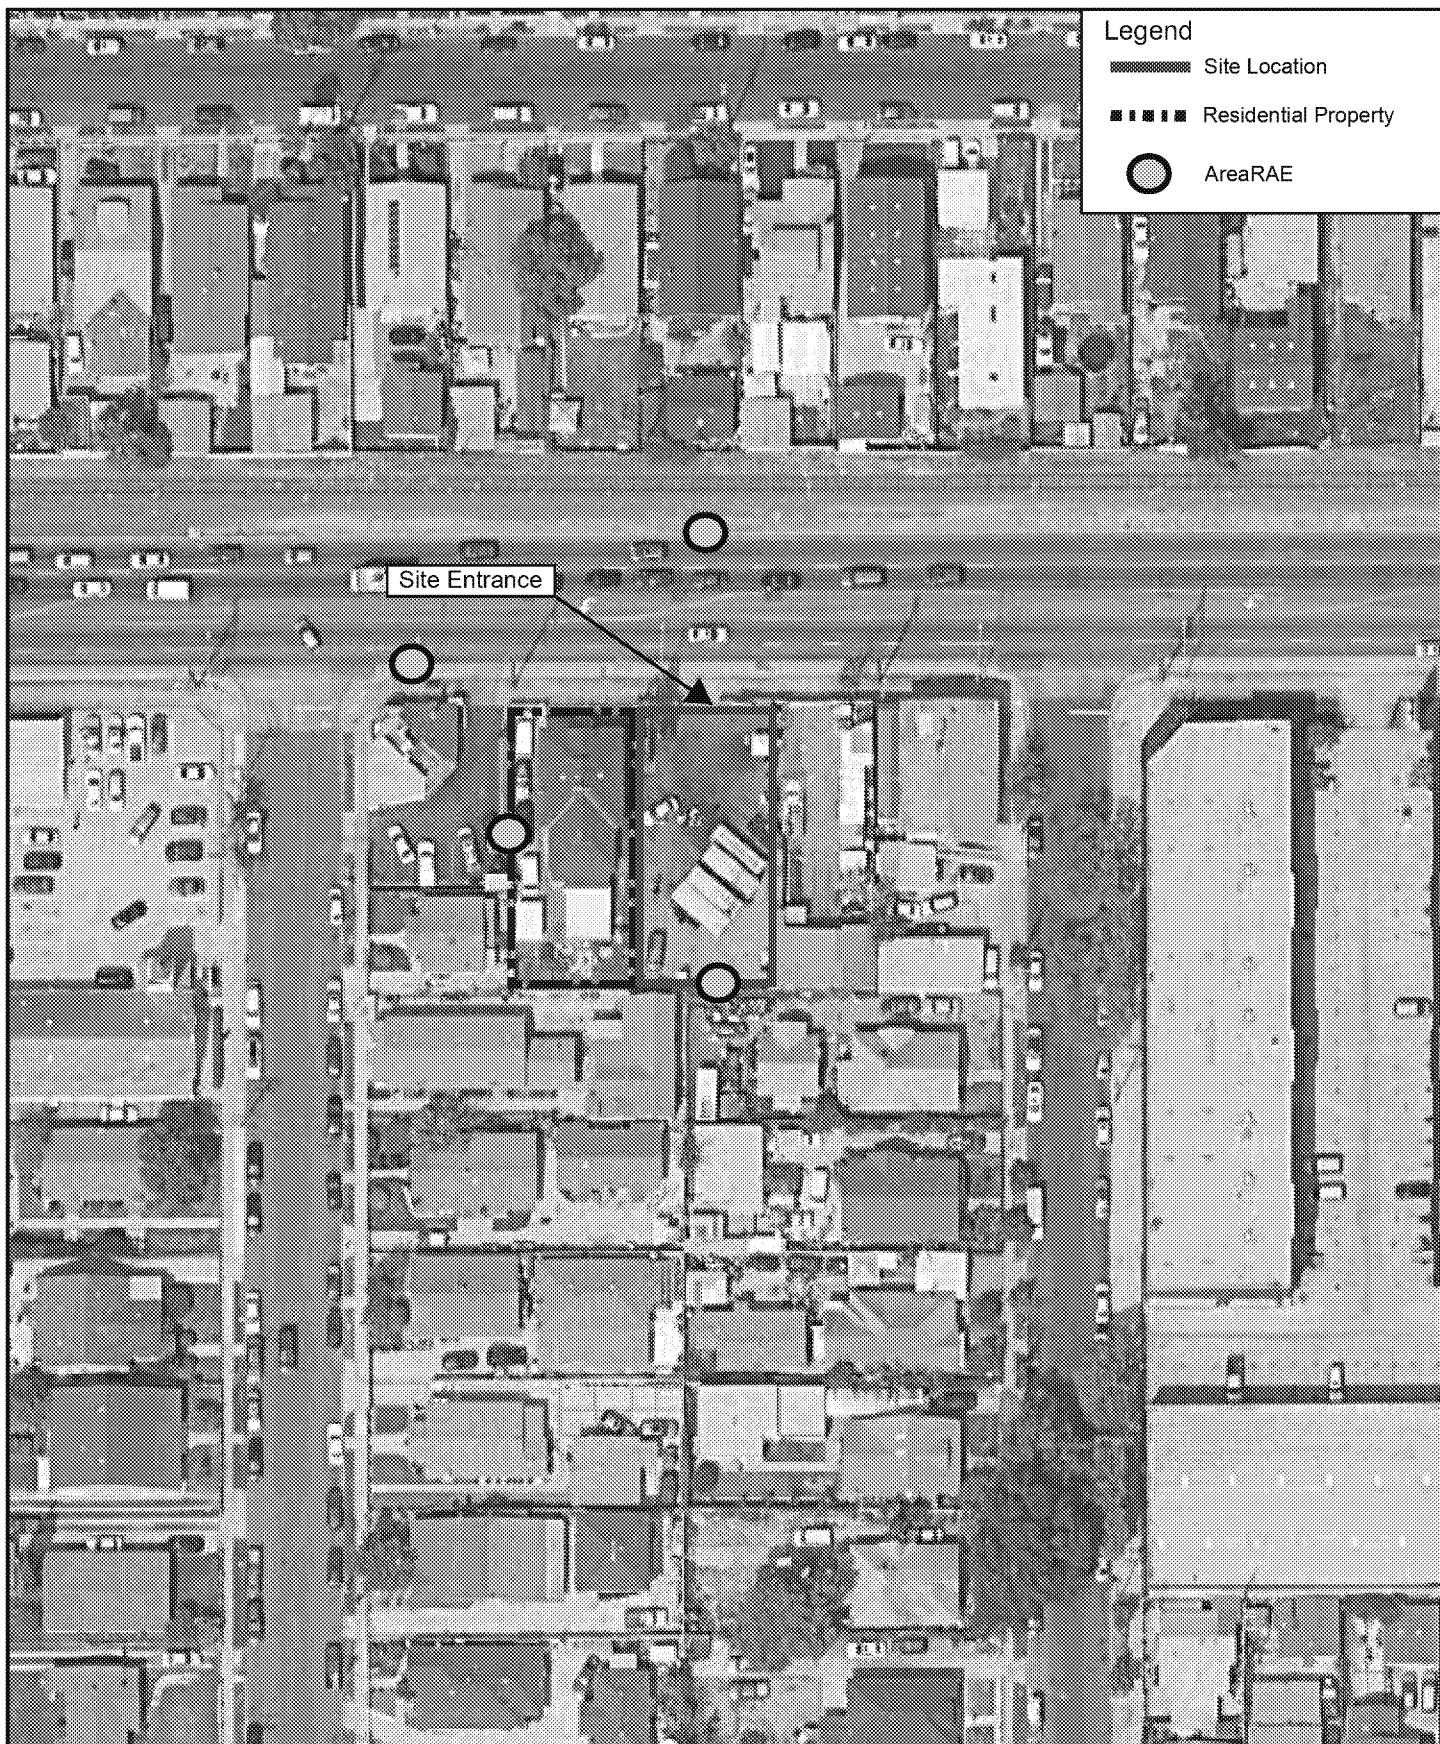
### FIGURE 3 AREARAE LOCATION MAP

START deployed a real-time perimeter air monitoring network around the Site using Honeywell AreaRAE Pro units equipped with sensors for VOCs, CO, H<sub>2</sub>S, LEL, and O<sub>2</sub>. The AreaRAEs were deployed at off-site locations to determine if vapors were migrating off site (Figure 3). AreaRAE readings did not exceed the Occupational Safety and Health Administration (OSHA) time weighted average (TWA) permissible exposure limit (PEL) at any of the off-site locations during the removal activities.

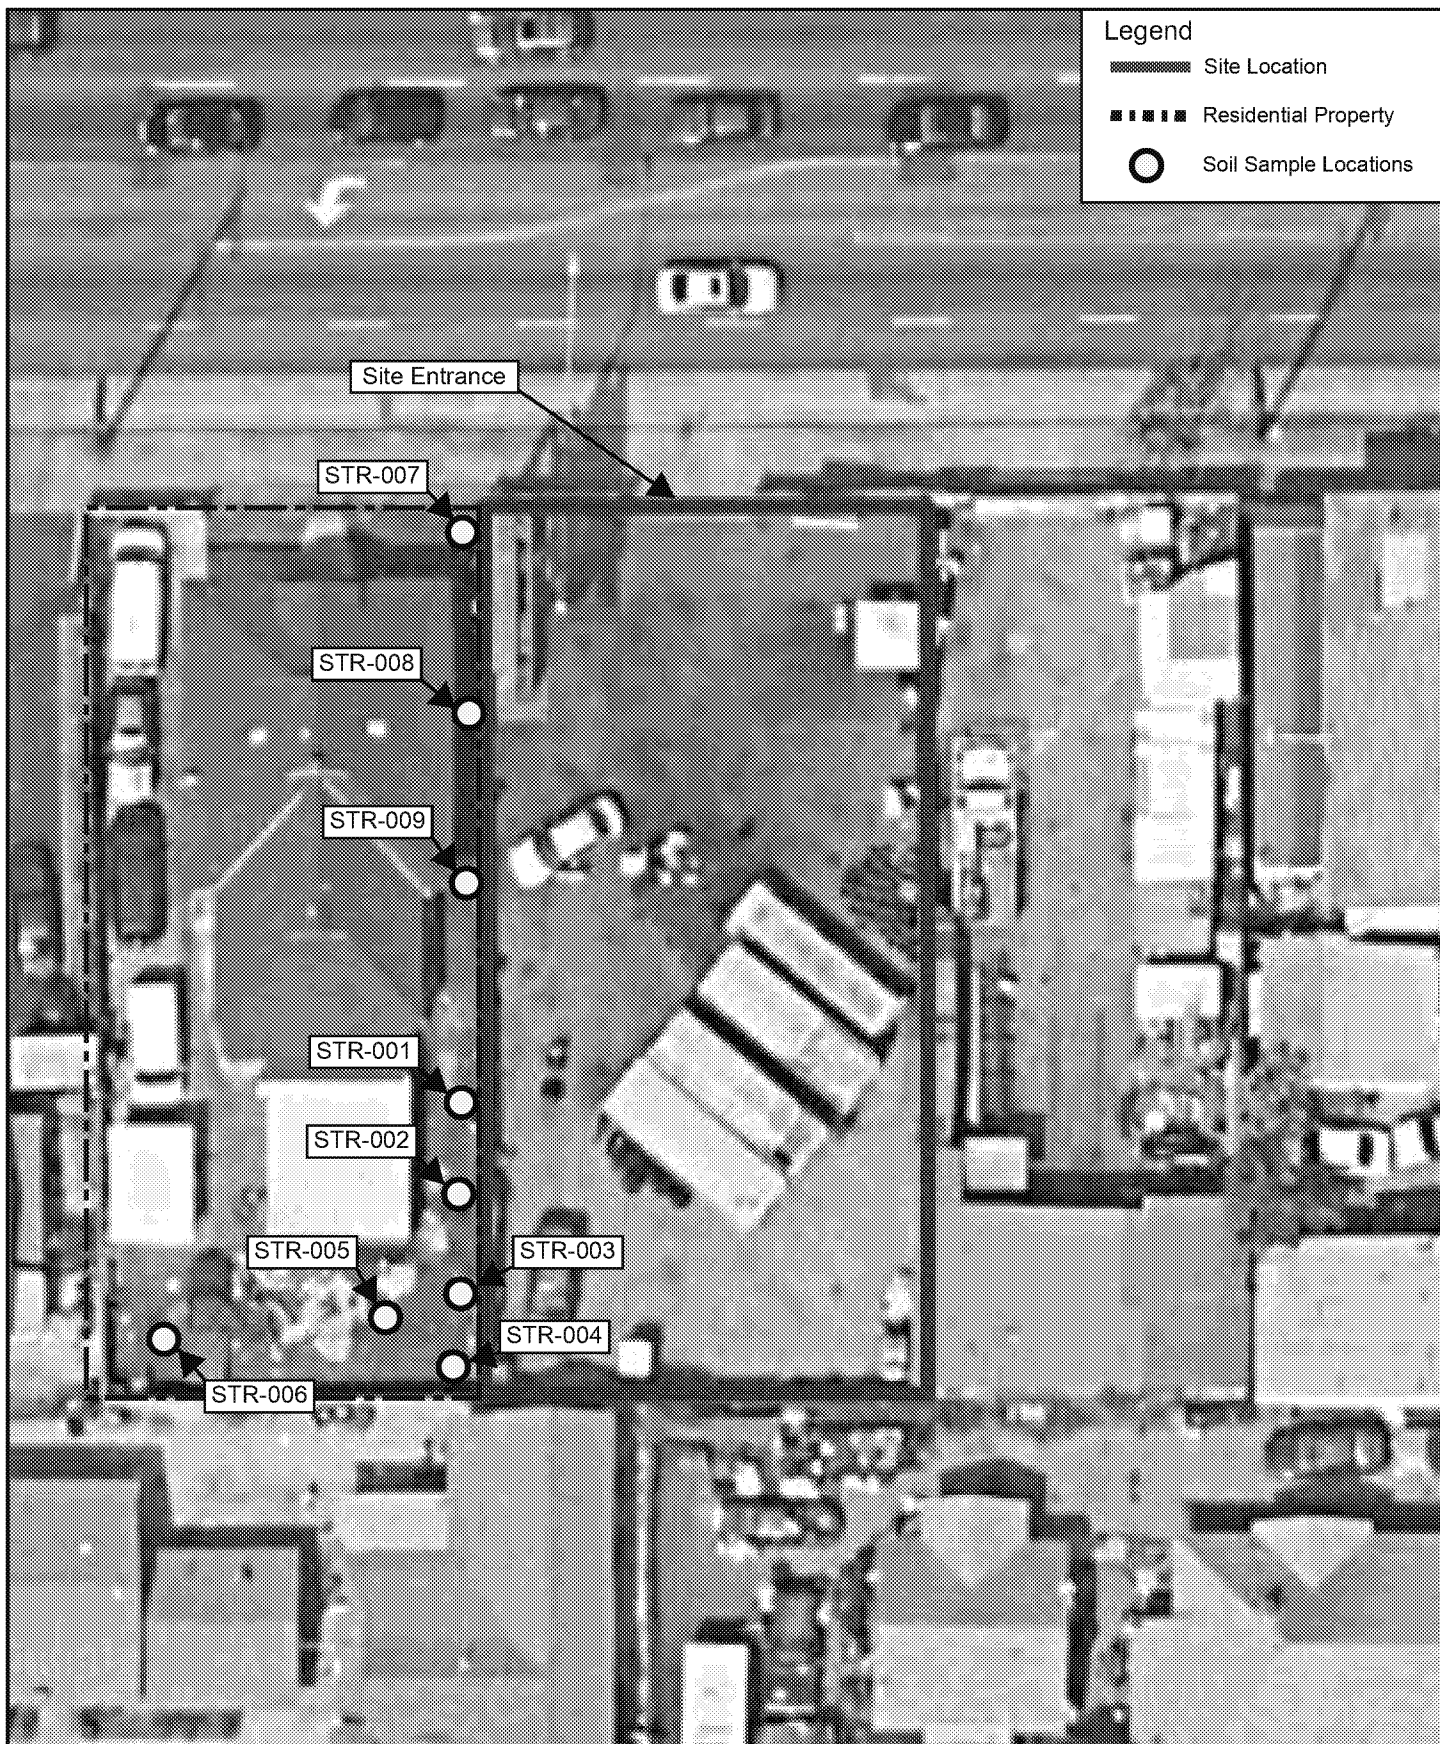
## FIGURE 4 SOIL SAMPLE LOCATIONS

On March 19, 2019, START was tasked to conduct a limited soil assessment of the adjacent property (216 West Slauson Avenue) to help determine the lateral and vertical extent of contamination related to the tanker release. Utilizing a hand auger, START collected soil samples from nine locations (STR-001 through STR-009) along the fence line between 210 and 216 West Slauson (Figure 4). The samples ranged in depth between the surface and at 5 feet below ground surface (bgs). Soil samples were field screened utilizing the TVA 2020 for VOCs. Readings were observed to range from 43 ppm to 260,000 ppm in the surface soil with the highest reading detected from the surface soil at STR-001 (Table 1).

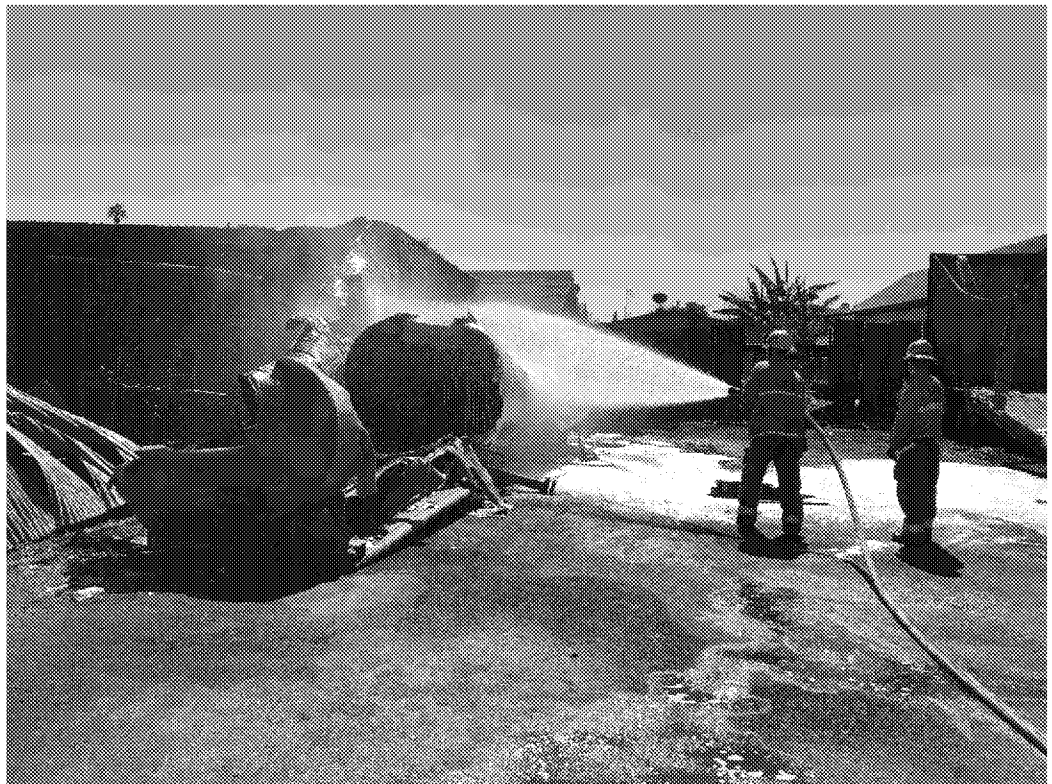
**Photo No.**  
**1**

Los Angeles City Fire Department suppressing gasoline odors from damaged Tanker.

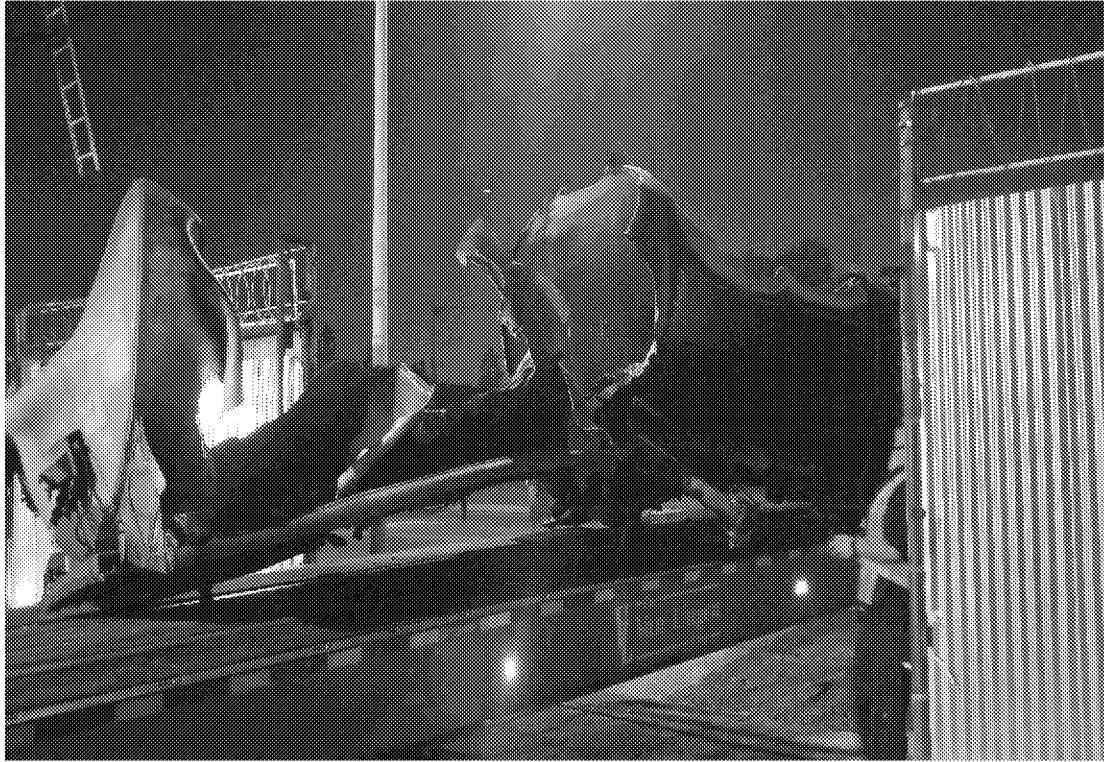
<b>Project Name:</b> Slauson Tanker Response		<b>Site Location:</b> Los Angeles, CA	<b>TDD No.:</b> 0002/1302-T2-R9-17-04-0002
<b>Photo No.</b> <b>3</b>	<b>Date:</b> March 18, 2019

<b>Direction Photo Taken:</b>  North			
<b>Description:</b>  Tanker shell being removed from the site.

On March 18, 2019, Clean Harbors removed the fire damaged tanker, the fire damaged trailer, and the fire damaged tractor trucks from the Site. An absorbent material was then placed on the Site surface to contain any remaining liquid. The absorbent material was swept up and placed into 55-gallon drums for eventual disposal.

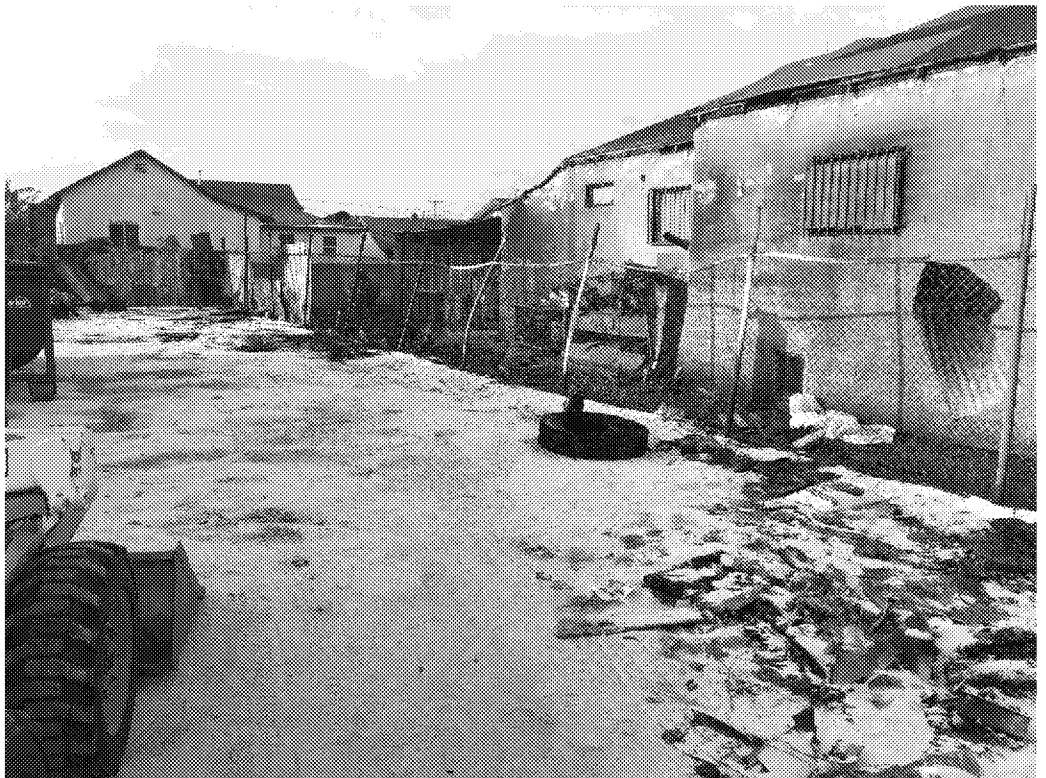
<b>Photo No.</b> <b>4</b>	<b>Date:</b> March 18, 2019

<b>Direction Photo Taken:</b>  Southwest		
<b>Description:</b>  216 W. Slauson Ave. adjacent property damaged during the incident.

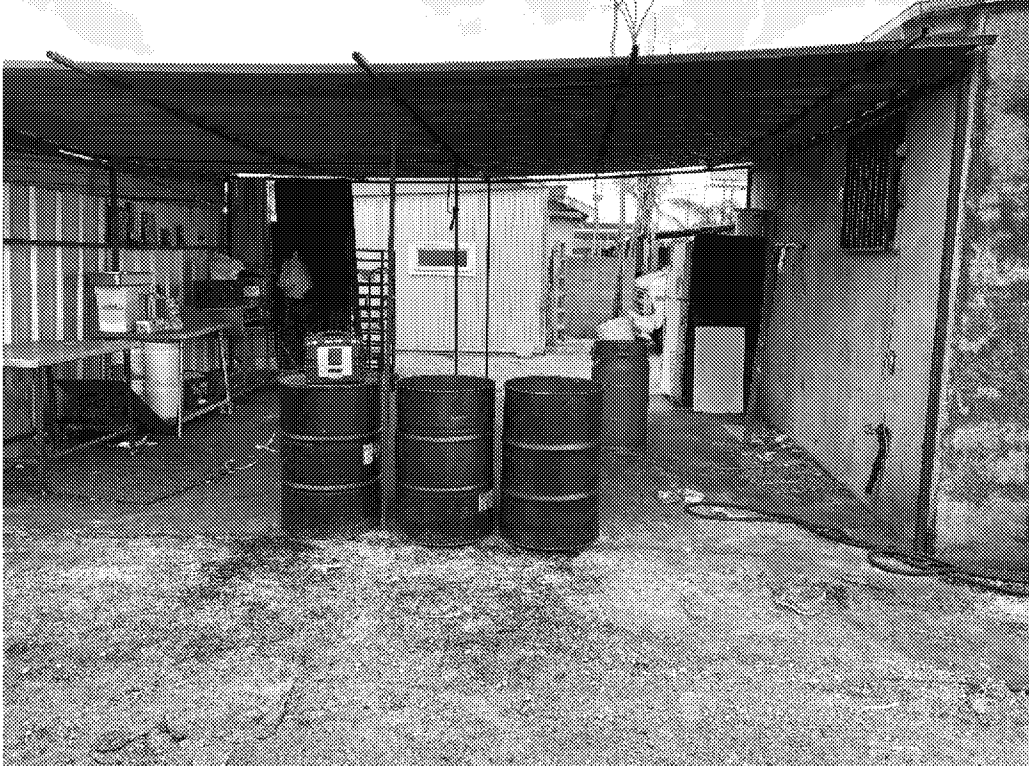
<b>Project Name:</b> Slauson Tanker Response		<b>Site Location:</b> Los Angeles CA	<b>TDD No.:</b> 0002/1302-T2-R9-17-04-0002
<b>Photo No.</b> <b>5</b>	<b>Date:</b> March 17, 2019

<b>Direction Photo Taken:</b>  West			
<b>Description:</b>  Perimeter air monitoring during clean up.

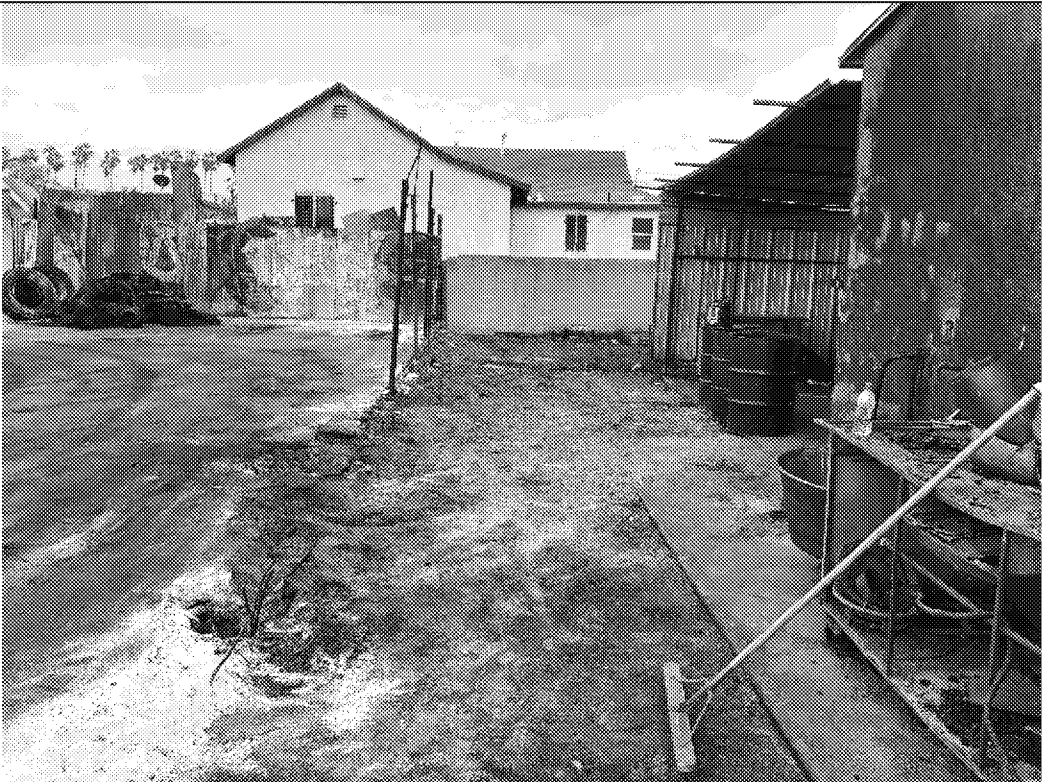
<b>Photo No.</b> <b>6</b>	<b>Date:</b> March 18, 2019

<b>Direction Photo Taken:</b>  Southwest		
<b>Description:</b>  Impacted soil on adjacent property.
